STEREO IMPACT

PROBLEM REPORT
PR-1007
SWEA LVPS LTC1877
2004-05-7

GODDARD SPACE FLIGHT CENTER
Failure Analysis Report

Microcircuit, Linear, Regulator, Step-Down

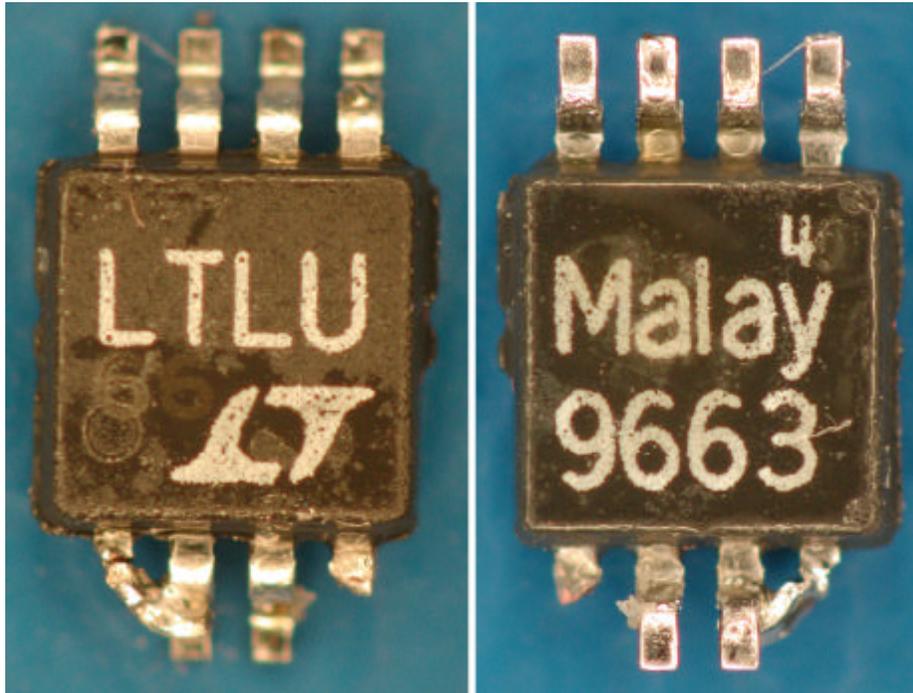
The as-received condition revealed no anomalies that might indicate device failure. Pin 1 was bent towards, and solder-bridged to, pin 2. Pin 4 was cut very close to the device package. The device had what appeared to be a laser scribed serial number (66) on its top surface (top and bottom views are shown in Figure 1). Radiographic inspection revealed no anomalies (Figure 2). C-mode acoustic microscopy (C-SAM) revealed delamination between the mold compound and the lead frame fingers, at both sides of the fingers (Figure 3). They were particularly pronounced on the wire bond sides (top). These features are considered a significant reliability risk due to the possibility of an open circuit wire bond, and thus, are rejectable per applicable inspection criteria.

Figure 1. External top and bottom images of the device as received. Pin 4 is the cut pin.

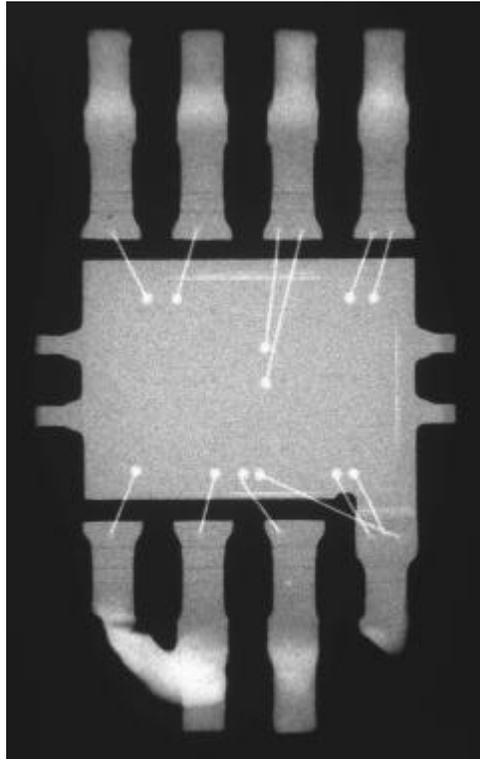
Figure 2. Radiographic image of the device. All bond wires are intact.

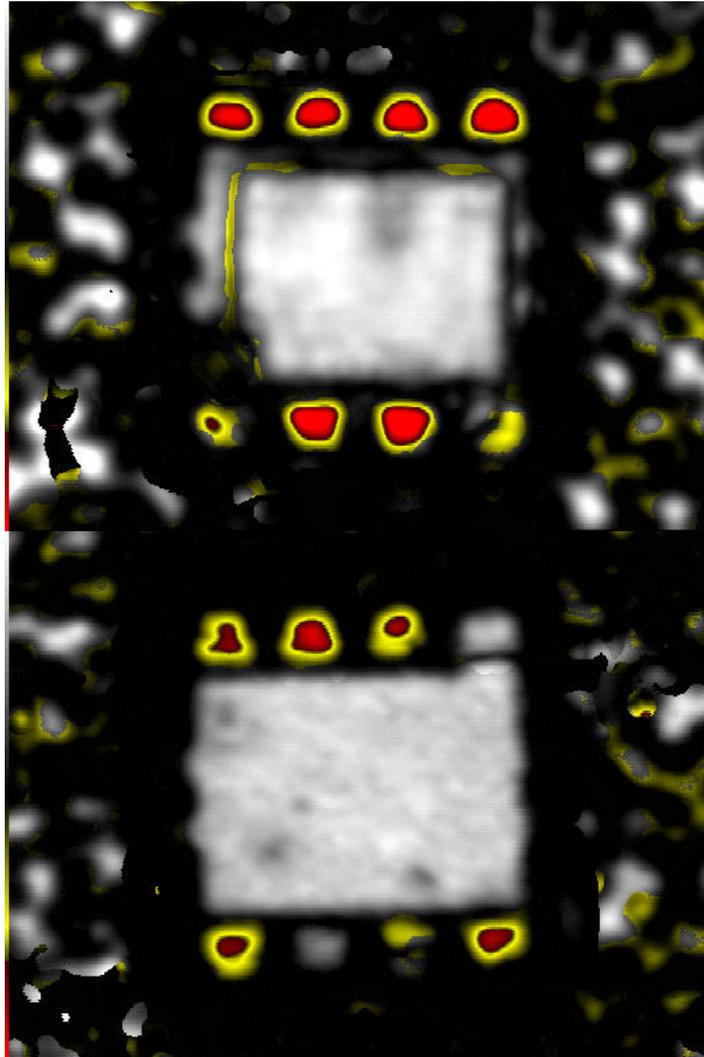
Figure 3. Top (l) and bottom (r) C-SAM inspection images show significant delamination at the lead frame fingers. These are not likely related to device failure since no open circuit conditions were observed.

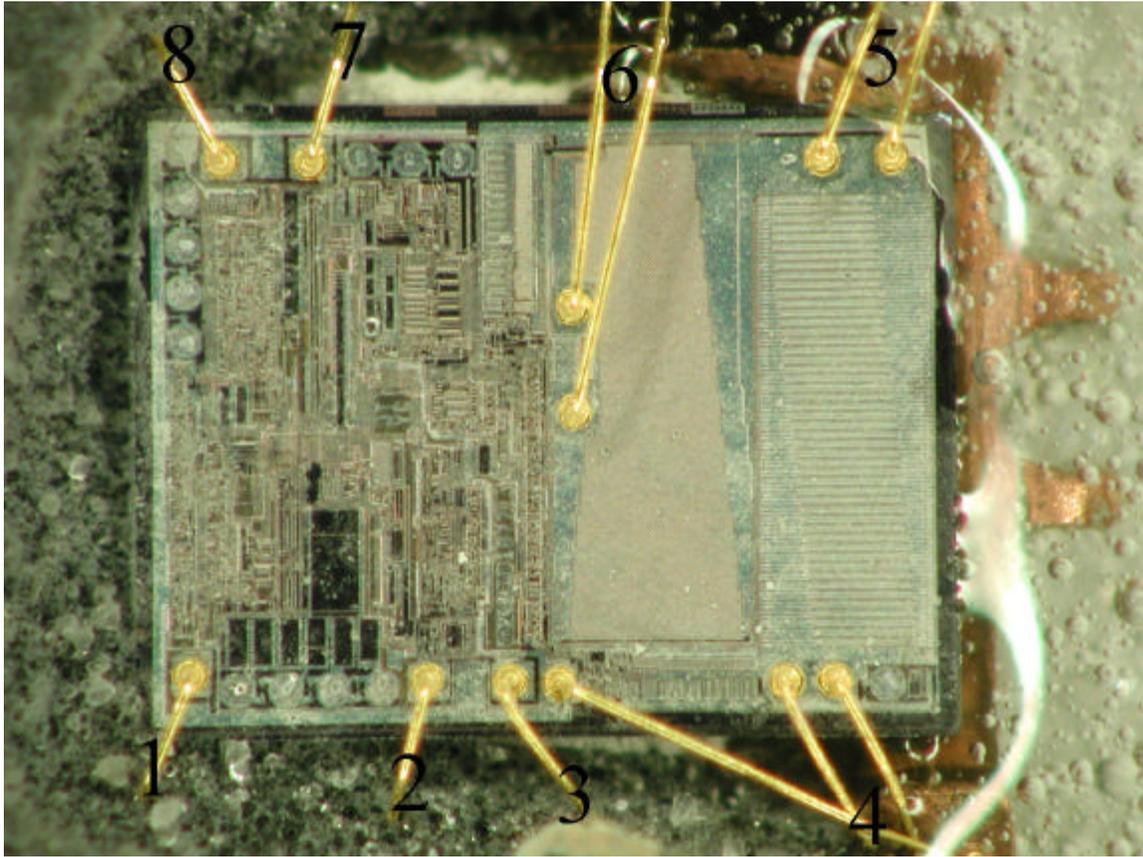
The failed device was deprocessed with nitric acid to reveal the die for inspection. The process left residual mold compound on the die surface making inspection somewhat difficult (Figures 4 and 5). Nonetheless, the entire die surface was inspected at 500X magnification under brightfield illumination, and in the scanning electron microscope (SEM).

Figure 4. Overall view of the device deprocessed and mounted for internal examination.

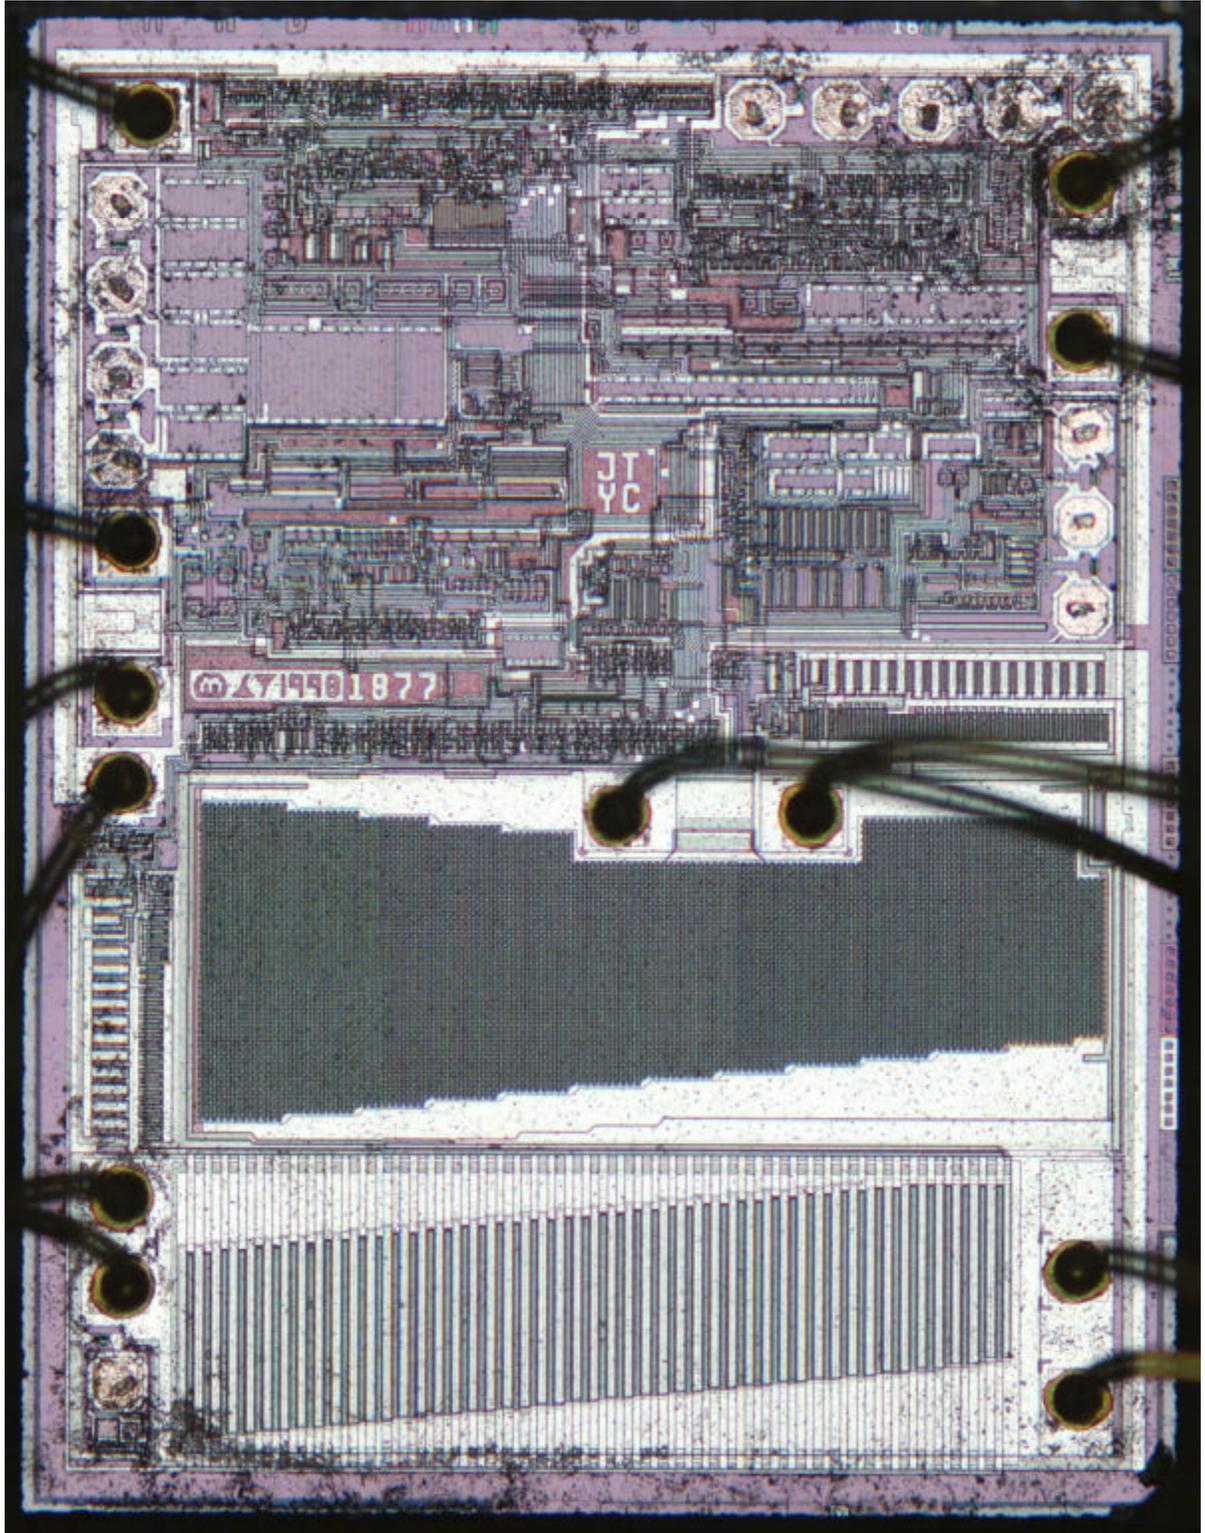
Figure 5. Overall image of the die.
