# STEREO IMPACT

PROBLEM REPORT

PR-1011

STEU FM1 Door 2

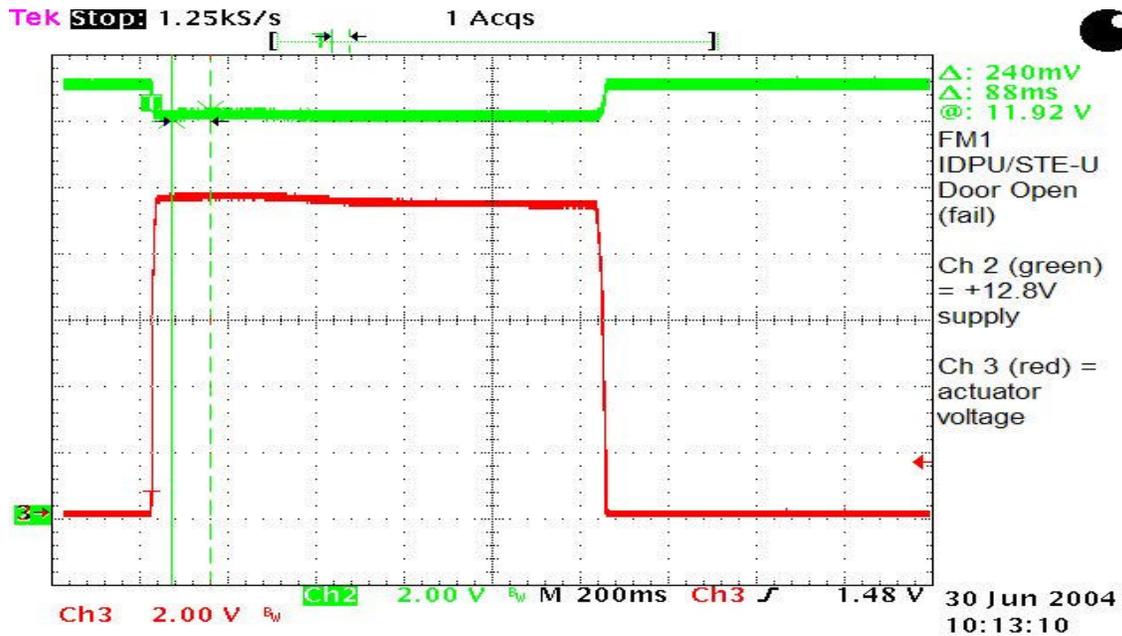
STE-U was removed from the boom (as planned) and further tests were performed on the door while monitoring the voltage waveforms in the IDPU (which drives the door). See the plot below. There is no sign of a problem with the actuator power or any intermittent in the actuator continuity, and current continues to timeout.

STE-U FM1 door open attempt (fails). Green trace is the supply that powers the door actuator; the voltage sag is within spec and as measured previously. The red trace is the voltage on the actuator (after a 15 ohm series resistor), and is also normal (the actuator resistance is ~55 ohms). The door power continues till timeout after 1 second without completing the door motion (normally when the door reaches the open position a sense switch closure causes the actuator power to be discontinued).

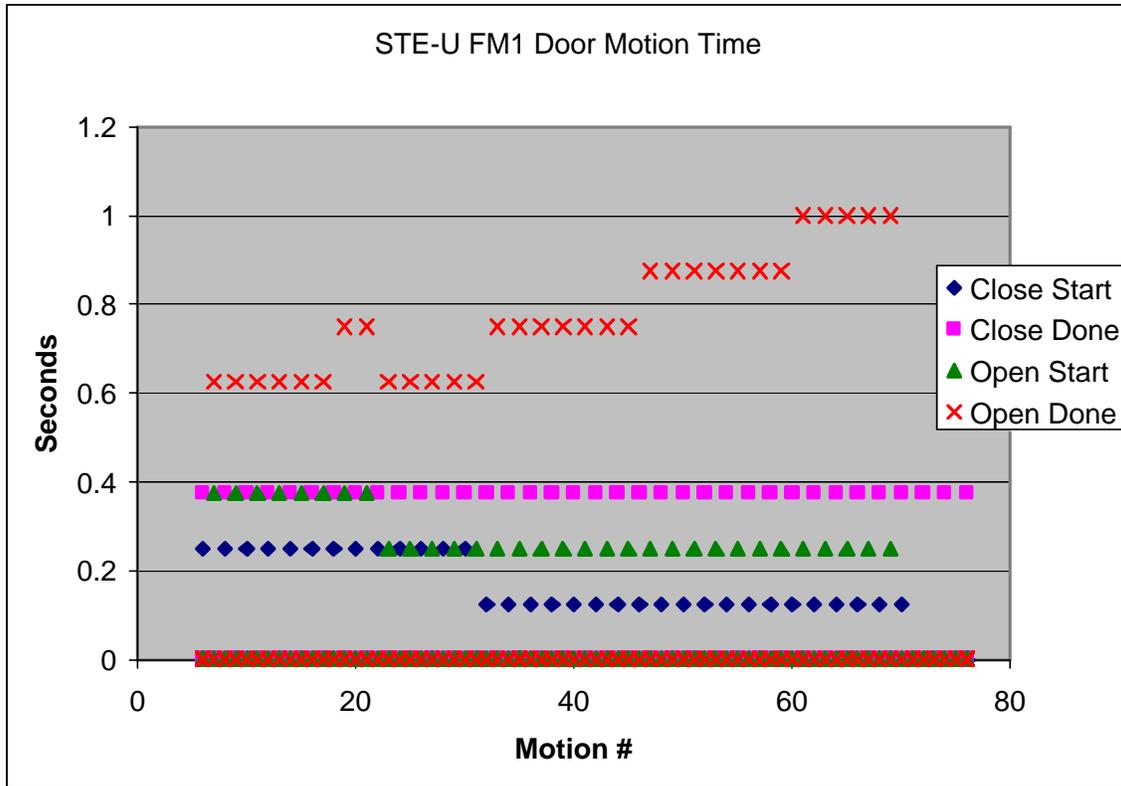
The cover was removed from the STE-U door actuator mechanism and inspected for any damage or foreign material, which was not found. The door actuator itself was not touched. The door was then actuated with a GSE and found to operate normally, though not smoothly. Margin in terms of lower actuator operating current were demonstrated. The cover was replaced without touching the actuator. The test with the IDPU was repeated several times and the door was found to open and close normally with the normal operation time. However after the door was cycled ~15 times the open actuation time started to increase, and after ~35 times it timed out. Note that the door had previously passed a 100-cycle test with no sign of trouble.

Door actuation times. Starts normally, but Open Completion time starts to rise and reaches the 1 second timeout after ~70 motions (1 open/close cycle is two motions). There is also a small downwards trend in the time it takes to start moving in both directions that may be significant. Note that the time measurement resolution is 1/8 second.

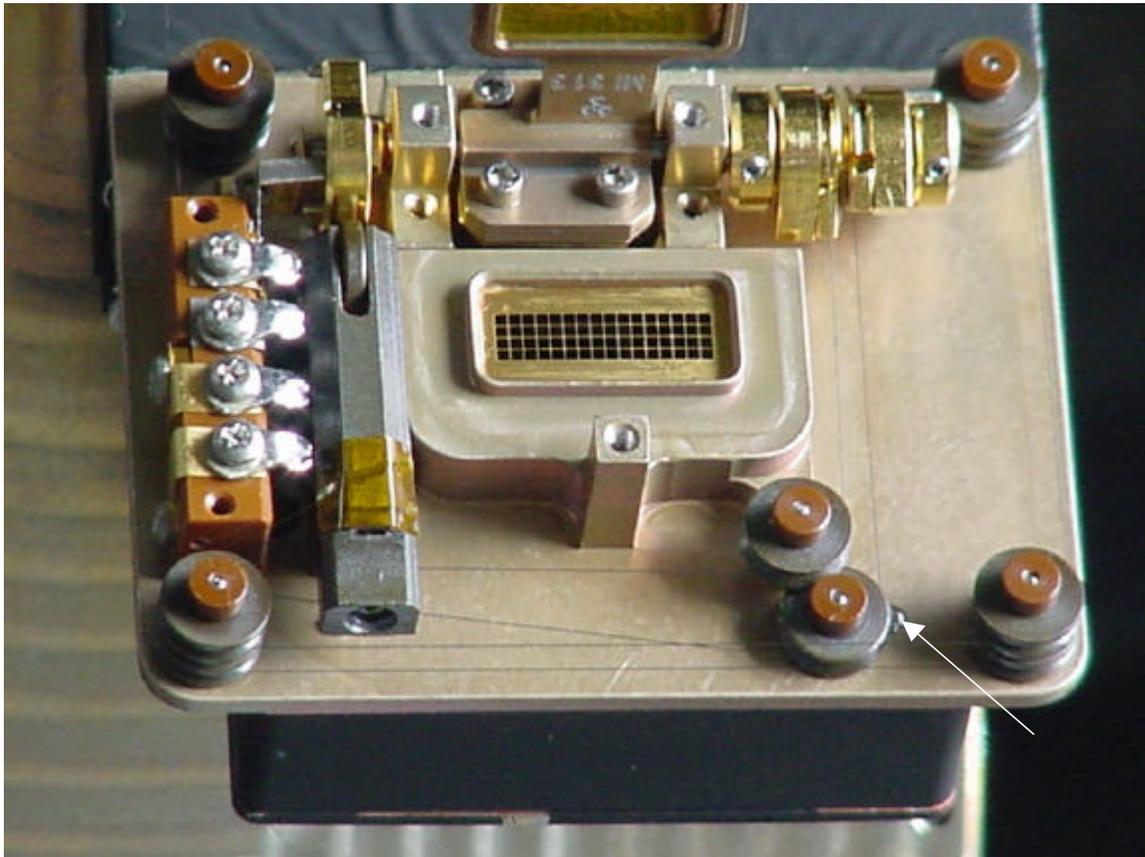
Inspection of the door operation while the cover was removed showed one of the actuator wire pulleys was not moving. It was found that one of the detector mounting screws was long enough to come through the chassis and touch the pulley, preventing it from moving smoothly. The detector was installed after the 100-cycle door test but before the thermal vac and vibration tests. Inspection of the detector mounting shows that a washer was omitted which caused the screw to be too long. The washer was installed and it was verified that the screw no longer touches the pulley.

Installed correct washer under detector mounting screw to avoid interference with the door mechanism.

The door was again actuated with the cover off and a much smoother and somewhat faster motion was observed. The pulley was observed to rotate normally. A 100-cycle test was performed while monitoring the actuation time and the door motion. The door continued to operate smoothly and the actuation time showed no trends.
