# STEREO IMPACT

PROBLEM REPORT

PR-1013

STE-U FM2 Door

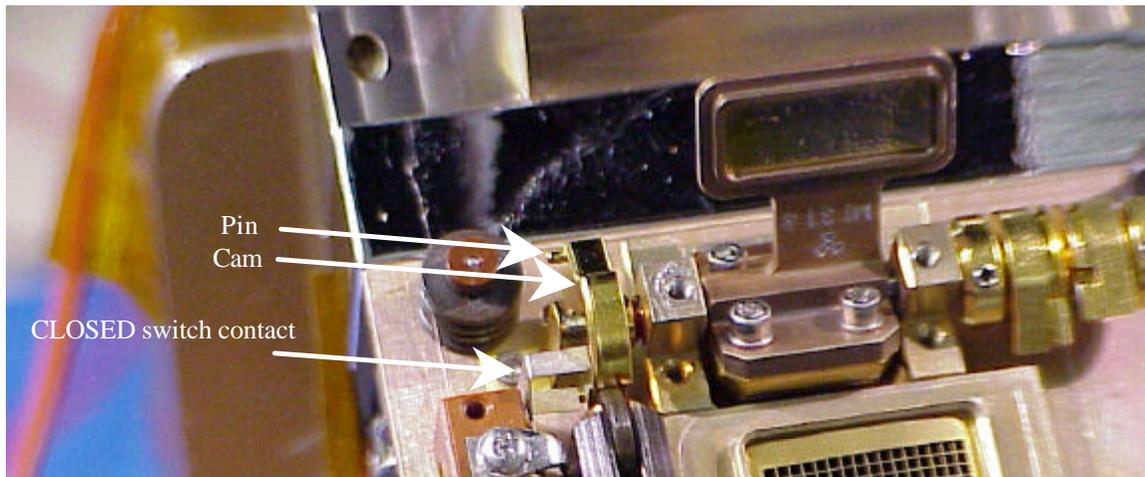
The instrument was warmed and removed from the chamber. The door sense switch was examined and it was clear that the switch was too close to the cam so that it could make intermittent contact with it, causing intermittent door status. This was overlooked in the original assembly, and it passed the original testing, but failed in thermal vac, probably due to differential expansion of the door elements. See attached pictures.

STE-U Door mechanism before fix

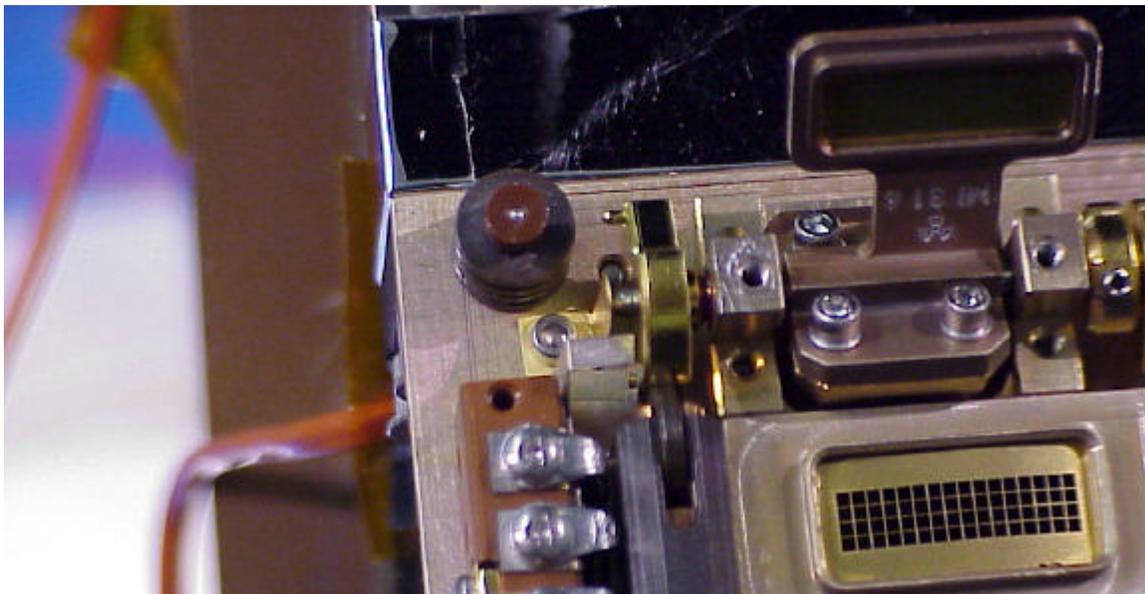
STE-U Door mechanism after fix

The door switch contact was shortened to provide adequate clearance to the cam. See attached pictures. The door was then cycled 100 times to verify consistent behavior before being returned to the thermal vac chamber.
