STEREO IMPACT

PROBLEM REPORT
PR-7007
SEPT TB Door test failure
2005-02-11

Assembly : SEPT-E (FM2)	SubAssembly : Door
Component/Part Number:	Serial Number: FM2
Originator: Lil Reichenthal	Organization: GSFC
Phone : 301-286-5634	Email : Lillian.S.Reichenthal@nasa.gov

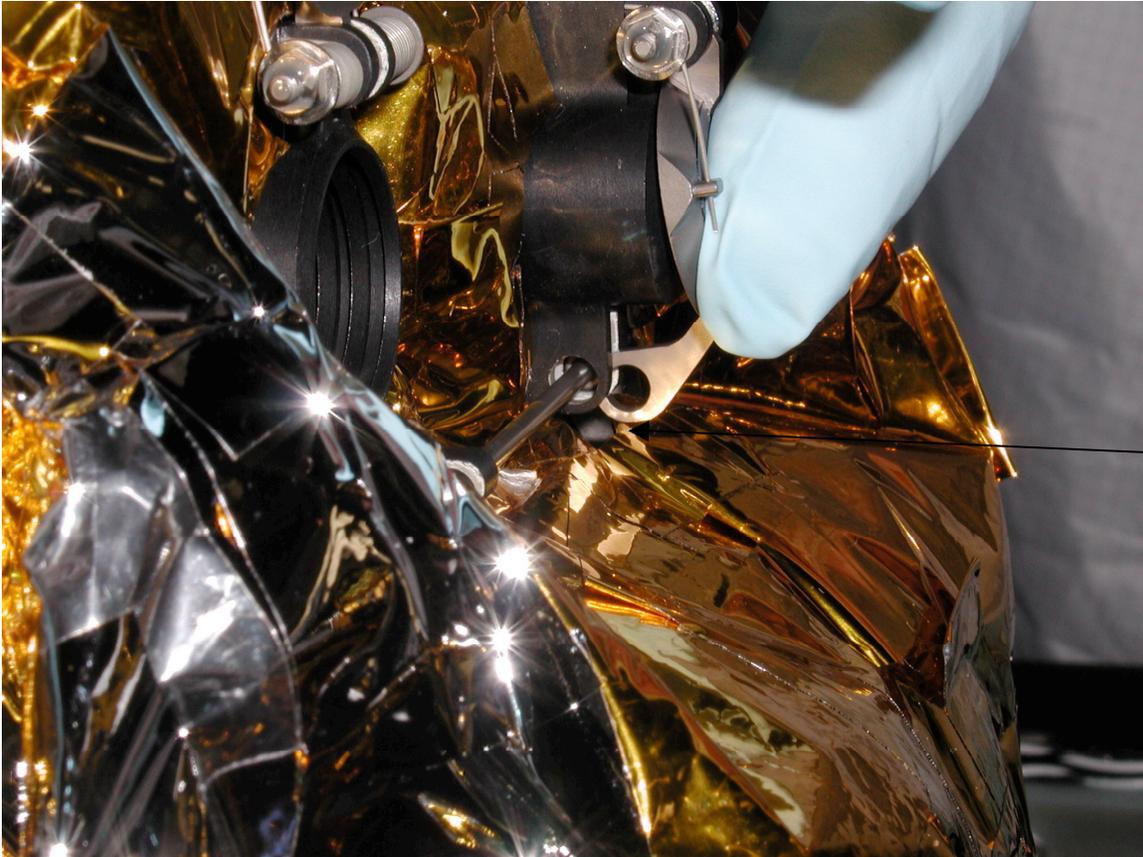
The chamber was opened on 3/9/05 at ~ 10:30 am and it appears that the blanket interfered with the door's latch-hook. Photo documentation of the interference points was collected at that time.

March 9, 2005 The door had opened while transitioning from hot to ambient. SEPT-NS FM2. (S/N 04). Note the contact between the door mechanism and the blanket.

- FRB held 3/9/2005. Agreed on a two segment approach to the MLI with the one segment of MLI near the apertures permanently attached using transfer adhesive. Implemented changes and reworked all of the SEPT flight blankets.

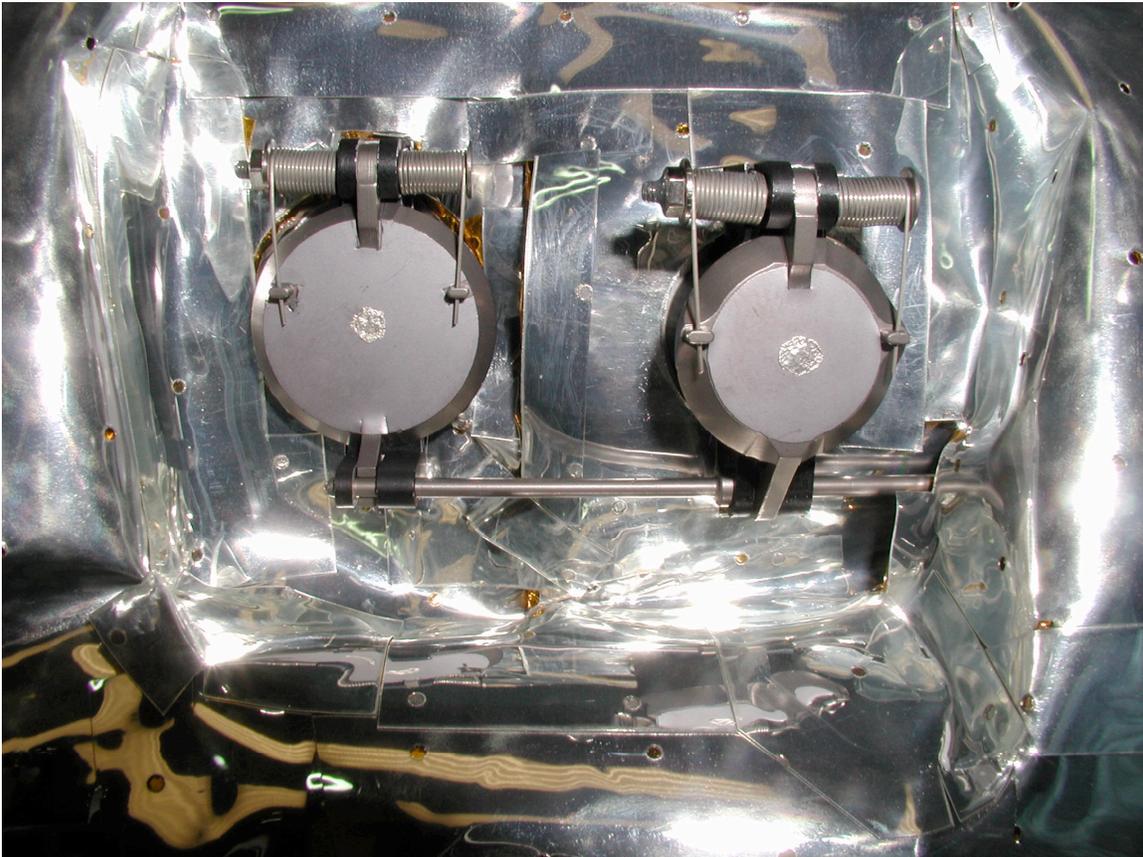
New blanket design which featured 2 blankets. One that was fitted around the apertures and one for the base of the unit. This new design that was implemented on all flight units. Note the clearance around the door mechanism.

Retested actuation of the SEPT-NS doors both hot and cold with the new flight blanket configuration.(WOA 545-289). All doors opened freely.
