# **SEPT Vibration Re-Test Report Preliminary**

**Doc. No.: STEREO-ETKI-011b**

**November 2004**

The purpose of this document is to give a preliminary analysis of the results of the SEPT vibration re-test which occurred at ESA/ESTEC from November 20 to 23, 2004. An official report (RD1) will be issued later by the facility.

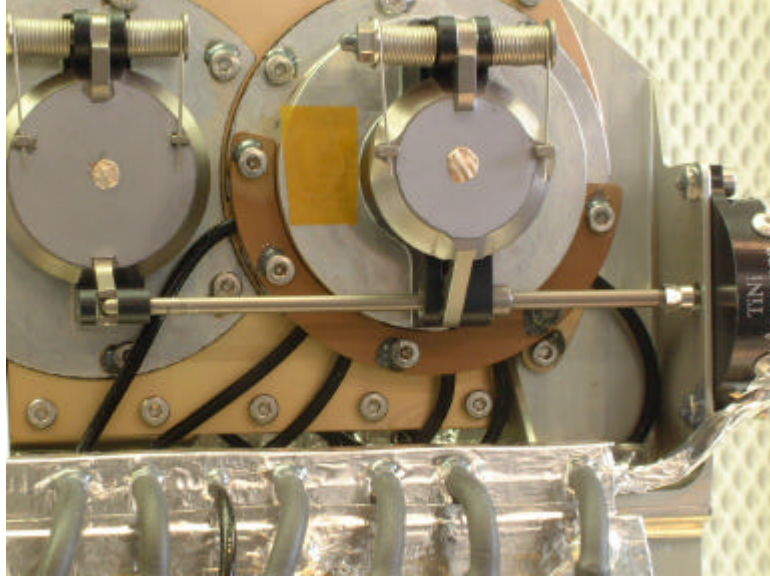
When attempting to open the doors on the rear side of SEPT-NS FM2 (i.e. side A) the pin-puller retracted correctly drawing 0.8 A for 45 ms as expected. However, both doors did not swing open, because the rod was still partly blocking the door clevises (see Fig. 8). Apparently, during vibration, the rod had loosened from the pinpuller pin because the rod was not sufficiently torqued into the pin tip which provides an internal thread. Inspection of side B showed an identical failure, so it was not attempted to open side B (see Fig. 9).

**Figure 8:** SEPT-NS FM2 side A after pin-puller actuation after vibration

This thread was not staked prior to vibration for the fear of losing a pin-puller in case of a disassembly later-on for some unexpected reason. As the mechanical specification from the manufacturer TiNi of the torque load was not clear to us (“nominal stress of 50 ksi stress”), the rod was torqued to good engineering practise only. An earlier attempt to apply adhesive on the rod/pin interface on the outside surface was discarded because this interface will move right to the hole drilled into the sensor mounting lug through which the pin is retracting.

The pin-puller of side A was re-stowed, the pin-puller rods of sides A and B were re-torqued to good engineering practise, the pin-pullers were actuated and the doors opened nominally with expected currents and activation times.

Having advanced thus far in the assembly and test program, we felt that it was justified to stake the thread on the pin-puller rods using Araldite 2014 adhesive. It was decided to stake all pin-puller-rods, even those who performed flawlessly after vibration. The SEPT materials list was updated to include Araldite 2014. A problem/failure report was issued (IMPACT PR-7006 SEPT-Rod). The four SEPT units proceeded to TV testing with staking applied.

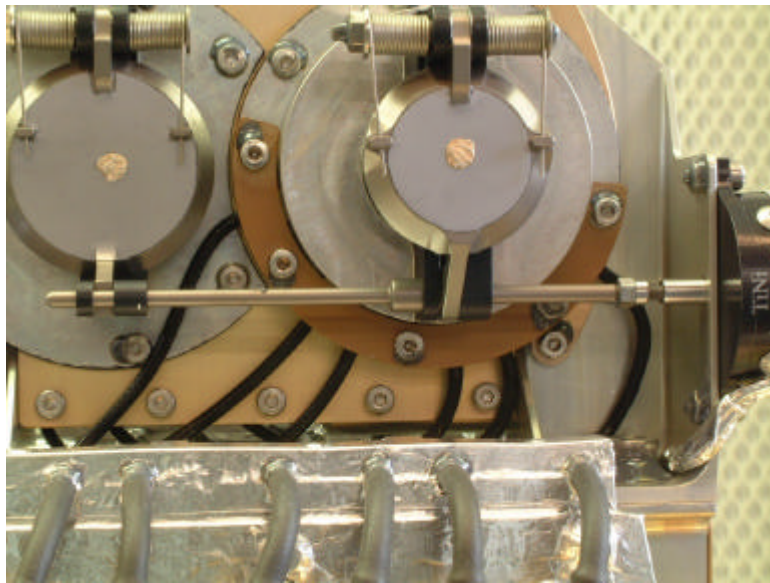
**Figure 9:** SEPT-NS FM2 side B after vibration, pin-puller actuation not attempted
