STEREO IMPACT

PROBLEM REPORT
PR-1007
SWEA LVPS LTC1877
2004-05-7

GODDARD SPACE FLIGHT CENTER
Failure Analysis Report

Microcircuit, Linear, Regulator, Step-Down

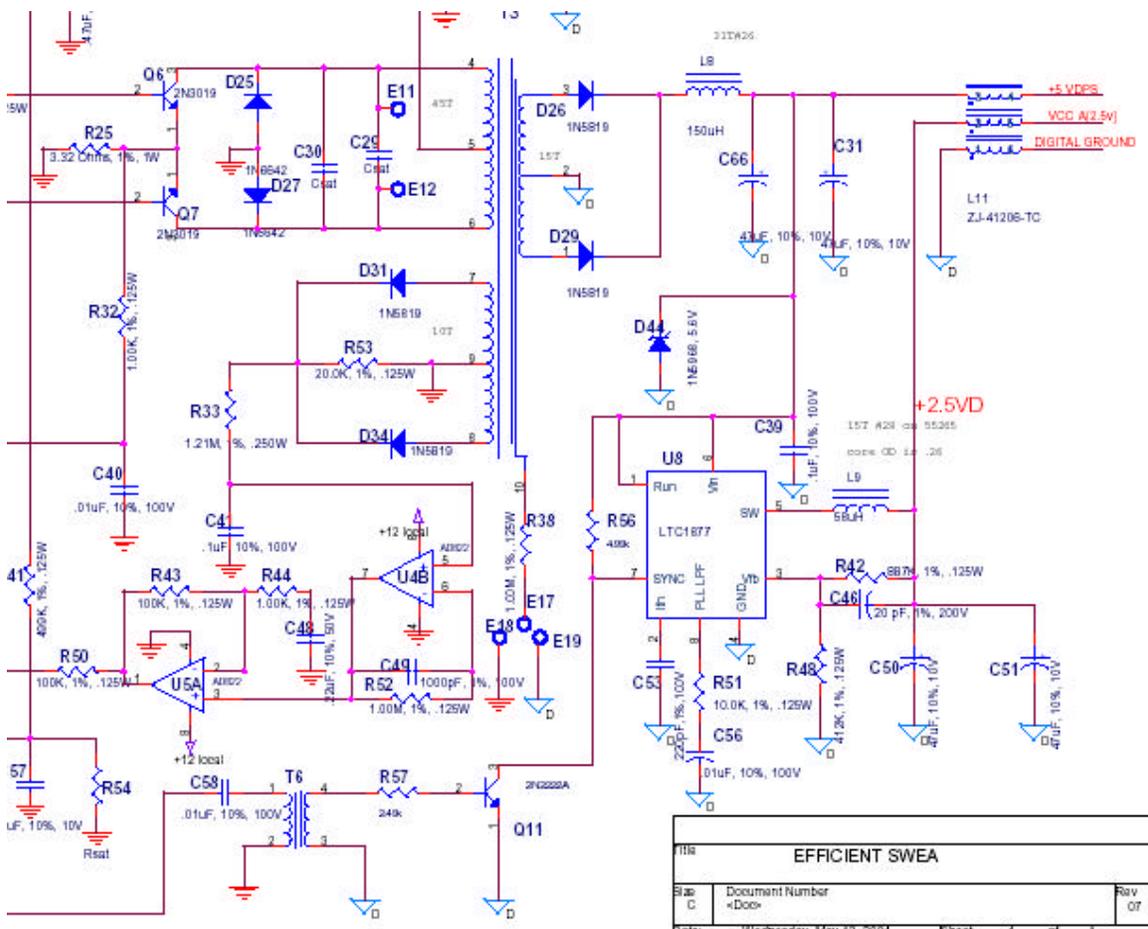
The LTC1877 wasn't regulating at all. (This was the first time the LVPS was powered and tested with the transformer installed that drives that section of the supply.) There are two outputs from that section. One is 5V; this output also powers the LTC1877, which is configured to give the other output, 2.5V. The 5V output was fine, but the 2.5V output also measured 5V. The supplies were unloaded. The regulator switching output (pin 5) wasn't switching, just sitting at the 5VDC power rail. With one exception the inputs measured as expected.

The exception was the voltage feedback input (pin 3), which expects to be at ~0.8V, with the external divider (R42 & R48) chosen to give the desired output voltage. This pin measured ~0.5V, and neither this voltage nor the output changed when I put another resistor in parallel with R42 or R48 to change the divider. Both resistors were the correct values, but the resistances and measured voltages had no correlation with the design equation for them. We concluded the only remaining explanation was a bad part, and replacing the part did correct the problem.
